# RDKB SADDLE LAKE DAM 2018 ANNUAL INSPECTION REPORT

Revision 0

On October 30<sup>th</sup>, 2018, Austin Engineering Ltd. (Austin Engineering), completed the 2018 Annual Dam Inspection of the Regional District of Kootenay Boundary's (RDKB) Saddle Lake Dam, located on Reservoir Road in Grand Forks, BC. This inspection satisfies the dam safety requirements for the Ministry of Forests, Lands and Natural Resource Operations and was performed in accordance with the Canadian Dam Association *Dam Safety Guidelines 2007 (2013 Edition)*.

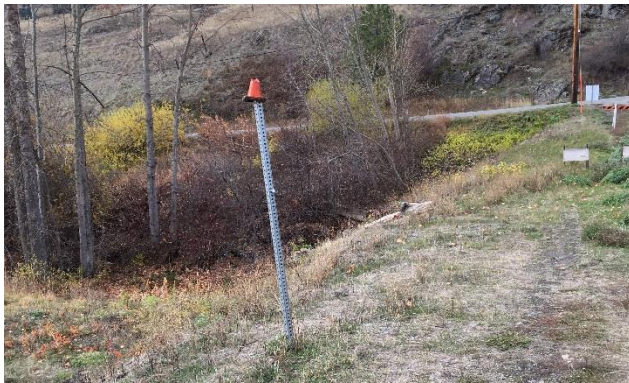
1. The sign that was previously located on the east abutment, indicating that Saddle Lake Dam is a dam as required by with the BC Dam Safety regulations, was no longer in place and has been removed.

**Photo 1:** Dam safety signage missing from east abutment – requires replacement.

1. Install spillway. **(VH)**
2. Replace the sign which provided Dam Safety information that was previously located near the east abutment of the dam. **(M)**
3. Install more effective barriers to physically limit traffic across the crest of the dam. **(M)**
4. Repair the ruts and depressions along the top of the dam. Repairs should include leveling, backfilling and reseeding to prevent any water from ponding on the top of the dam and reducing the stability of the earthen embankment. **(M-H)**
5. Remove vegetation growth on the east side of the downstream slope of the dam and implement a maintenance schedule to ensure vegetation growth is monitored and removed as required. **(M)**

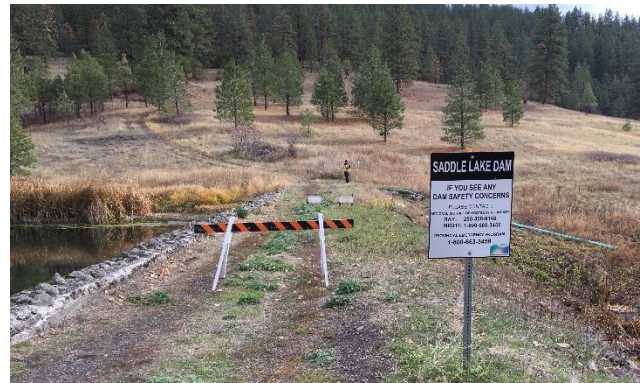
2. Small barriers that were noted during previous inspections have been reinstalled at the access point for crossing the dam. These barriers are easily removable and likely act primarily as a deterrent rather than physically preventing vehicles from crossing. Austin Engineering recommends installing effective barriers to stop traffic from crossing over the crest of the dam.

**Photo 2:** Small barriers on dam crest to deter vehicle traffic, and intact dam safety signage on west abutment.

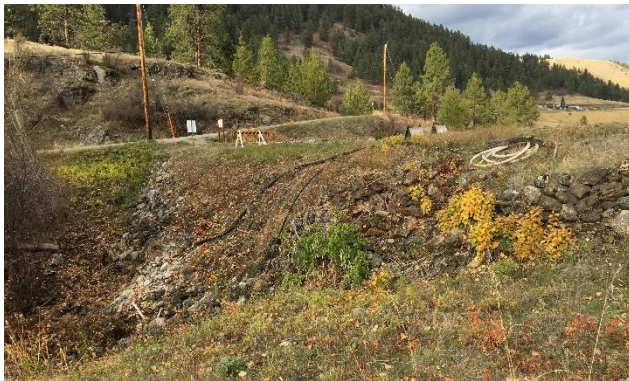
5. Some the downstream riprap is raveling due to the rock being oversteepened. Austin Engineering has made a recommendation below to install additional riprap as part of the spillway upgrade project.

**Photo 3:** Over-steepened downstream toe to be addressed during the spillway upgrade.

6. Install additional riprap to change the downstream slope angle and enhance the stability of the toe. Austin Engineering recommends completing this installation as part of the upgrades to the spillway. *(H)*

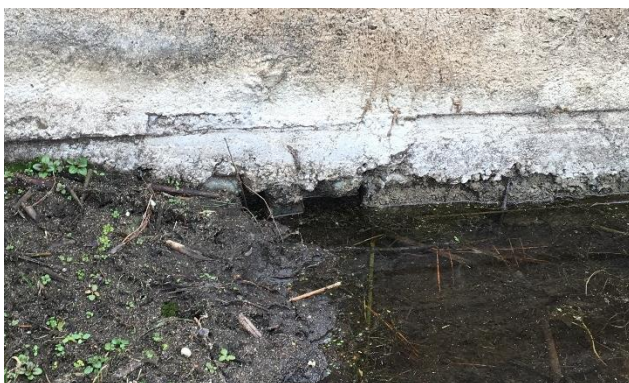
14. An 8-inch-wide by 2.5-inch-deep hole with a rough surface was noted in the east side of the upstream concrete face of the dam. This hole is suspected to be the result of an aggregate having dislodged out of the face at this location. Repair and patch concrete in this void to ensure continuity of the water barrier.

**Photo 5:** Hole in upstream east side of concrete face of the dam.

13. Consider budgeting to patch the concrete surface on the upstream face of the dam to extend the life of the concrete and protect against freeze-thaw action. However, at this time only minor levels of deterioration are present, and the concrete is in generally good condition where visible. *(M)*

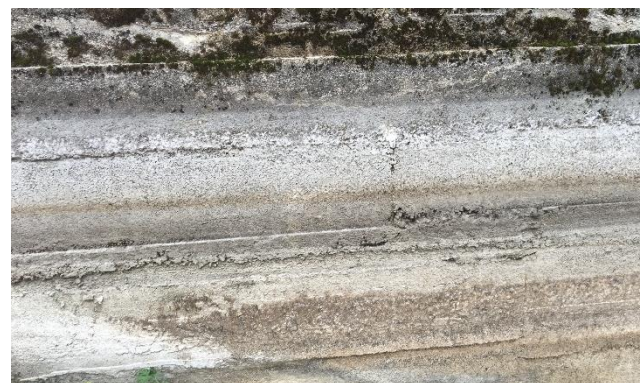
13. The water level of Saddle Lake was noted to be 681.15 m (measured off of the 683.00 m marker on the dam) at the time of inspection. This is a lower water level than previous years of inspection due to a planned gradual draw down in preparation for spillway construction. The condition of the upstream concrete face appears to be in good condition and no cracking, settling or overturning was noted during the inspection. While the upstream concrete face of the dam is visibly in good condition, it should be noted that only the portion above the water can be visually inspected.

**Photo 6:** Upstream concrete face in generally good condition; consider patching concrete to extend the life of the dam.

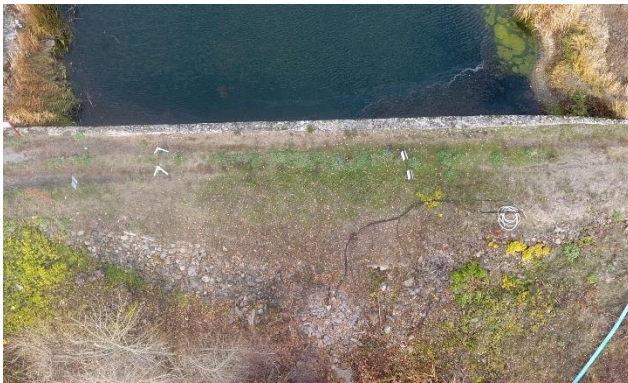
3. Wheel ruts were visible along the crest of the dam in the form of continuous depressions, which create zones where water can collect and penetrate the top of the dam. The ingress of water through these zones acts to decrease the effective stress of the soil and therefore decreases the stability of the downstream earth portion of the dam. While barriers are set up to prevent vehicles from crossing, the ruts can also be attributed to smaller vehicles, as the dam provides access to local trails.

**Photo 7:** Visible wheel ruts on dam crest.

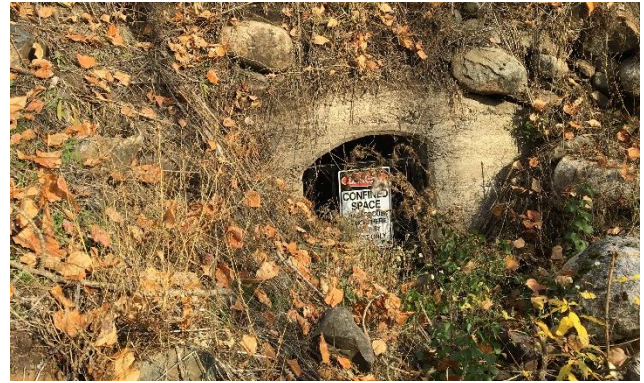
10. The gate and signage on the downstream tunnel and valve access appeared to be in good condition; however, they are partially hidden by vegetation, somewhat limiting their effectiveness at preventing people from entering this confined space. The inside of the valve chamber was not inspected during this site visit due to confined space hazards.

**Photo 8:** Valve chamber appropriately signed and gated (inside of valve chamber not inspected due to confined space access requirements).

9. Conduct further investigation of the original discharge valve behind the gated 'confined' space area, as it is a weak point in the dam's ability to retain control of the water. This piping should be inspected to confirm its condition and the concrete chamber should be pumped to better establish seepage/leakage rates. *(H)*

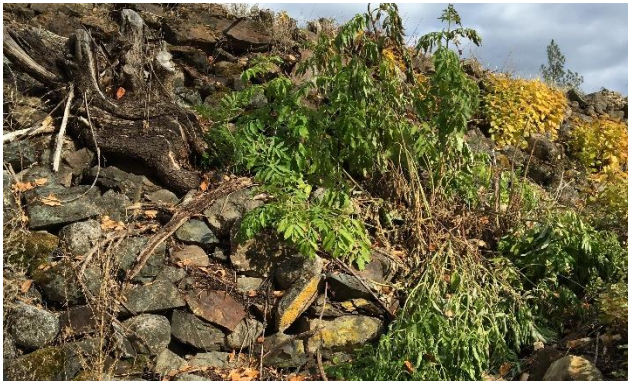
**Photo 9:** Some vegetation growth noted on downstream east slope which should be cleared.

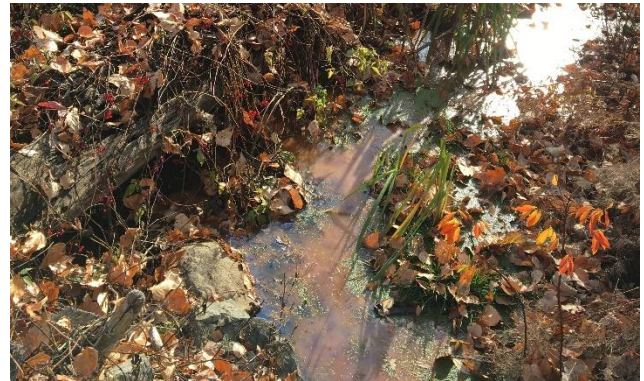
12. On the downstream side of the dam, standing water was found that is likely attributed to seepage flows from the dam. As noted in previous inspections, standing water lowers the safety factor of the dam and reduces its overall stability. Removal of debris downstream could dissipate this standing water and improve overall dam stability.

**Photo 10:** Seepage flow throughout the dam resulting in standing water near toe. Widen the trench width and maintain trench to avoid pooling at downstream toe.

11. Widen the trench downstream of the dam from 1 ft wide to 2 ft wide to facilitate draining of the standing water below the dam. Removal of this standing water will increase the stability of the earthen portion of the dam. *(H-VH)*

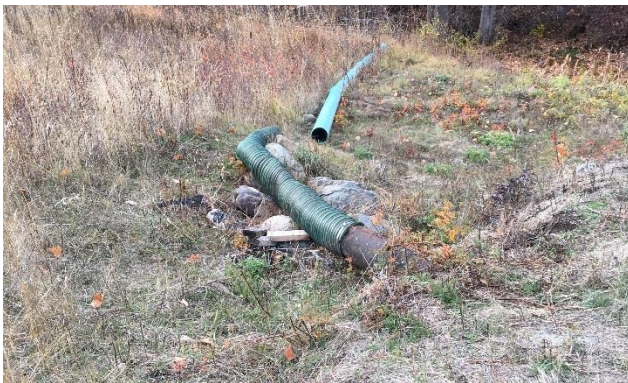
8. Austin Engineering noted the small overflow pipe located on the left abutment. This pipe is insufficient from a dam safety perspective to ensure that an overtopping event does not occur. The downstream end of this pipe was attached to plastic piping likely in place to divert water away from the downstream face of the dam. This plastic piping was noted to be disconnected and would require reconnection to effectively convey water away from the dam structure.

**Photo 11:** Piping used by the dam operator to diver pipe discharge water from eroding dam. Reconnect piping..

7. Relocate the hose laying across the midsection of the dam crest and reconnect corrugated plastic diversion piping to the overflow pipe. These measures will keep water from discharging onto the downstream slope of the dam if either the hose or discharge pipe are in use. *(H)*

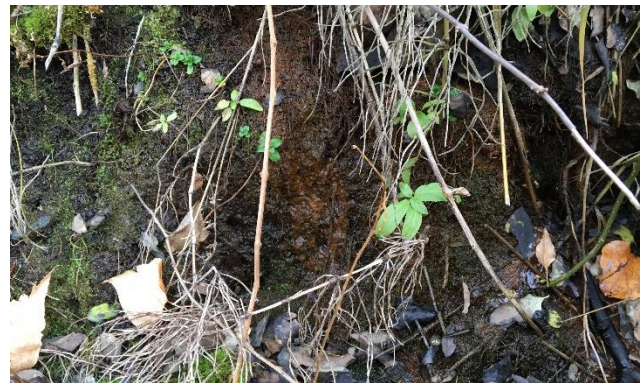
11. The precast riser structure located directly downstream of the dam is still surrounded by saturated soil and an active seepage location was noted in the vicinity. It is Austin Engineering's understanding that the riser structure has not yet been pumped dry or inspected. The seepage in this location should be closely monitored during inspections as pipes may extend from the upstream side of the dam to this precast structure, seepage may indicate a failure in these pipes

leading to potential piping and seepage may indicate a failure in these pipes leading to the potential for progressive internal soil erosion at this location. Austin Engineering highly recommends pumping this area and conducting a closer inspection of the precast rings.

**Photo 12:** Active seepage noted on downstream east side of dam near precast riser.

10. Monitor closely and conduct further investigation of the precast riser structure located directly downstream of the dam. As this structure is surrounded by saturated soil, Austin Engineering recommends removing the cap and pumping out any water to facilitate further inspection and confirm whether this structure is still in active use. *(VH)*

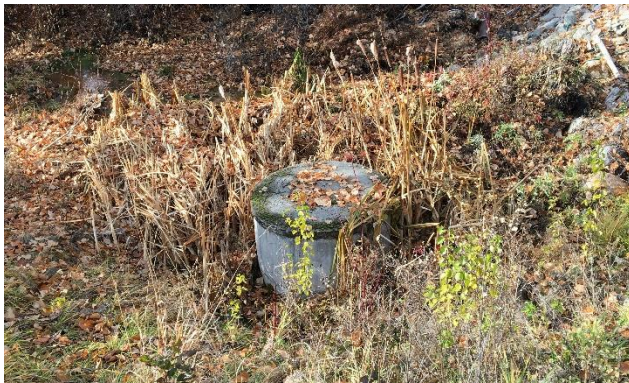
**Photo 13:** Precast riser structure located downstream of the dam is surrounded by saturated soil.

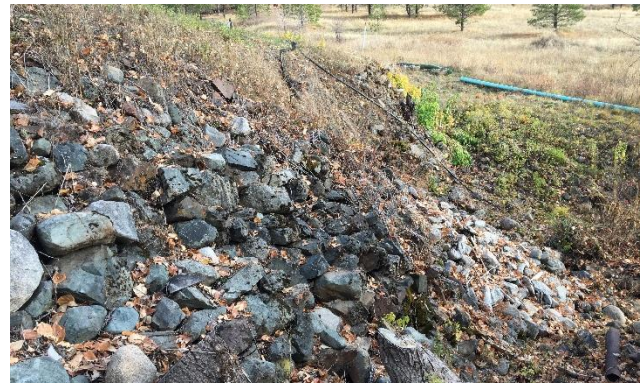
**Photo 14:** Some raveling of riprap noted on the over-steepened downstream slope.

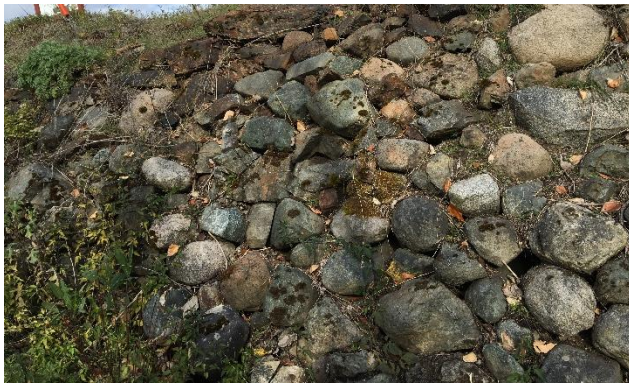
7. The seepage location previously noted on the downstream side of the west abutment was dry at the time of inspection, however, moss and signs of seepage were still evident at this location. The lack of visible seepage at this location is likely due to the lower reservoir level at the time of the 2018 inspection. Austin Engineering has made a recommendation below to install a weir to enable monitoring of the seepage flows and better assess the risk of this seepage to the structure.

**Photo 15:** Moss, which noted a previous seepage location on downstream west slope, was dry, likely due to low water level at time of inspection.

8. Install a weir to monitor any changes in seepage and to allow the operator to identify any changes in the steady-state condition of the dam. *(M-H)*

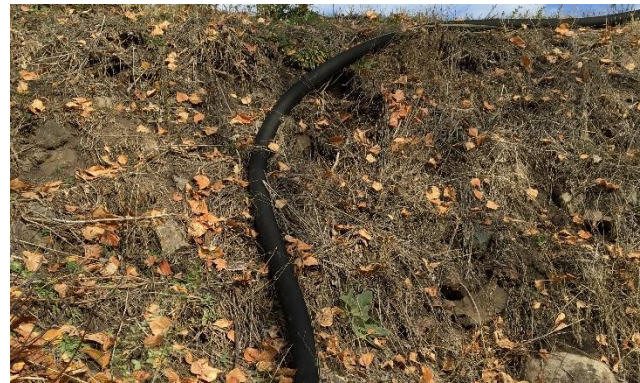
6. A hose was noted on the crest/downstream face at approximately the centerline of the dam. This hose may have contributed to material movement on the downstream face of the dam. The discharge end of the line was resting midway down the downstream face of the dam near the centerline. Water should not be discharged at this location. While this hose was not currently discharging, the discharge end should be extended from this location to the streambed below the dam to avoid future discharge onto the downstream face of the dam.

**Photo 16:** Hose laying across downstream face at approximately the centre of the dam appears to have eroded material off of the downstream face.

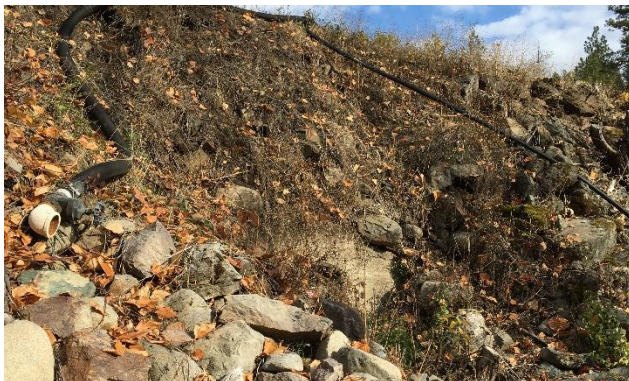
**Photo 17:** Discharge end of hose (not currently discharging) is located on downstream dam face and should be extended prior to use.
